**ENGLAND'S HOME INSPECTION
SERVICES LLC.**

4 POINT INSPECTION

123 ANYWHERE TOWN, FL 33333

INSPECTION DATE: 04/25/2023

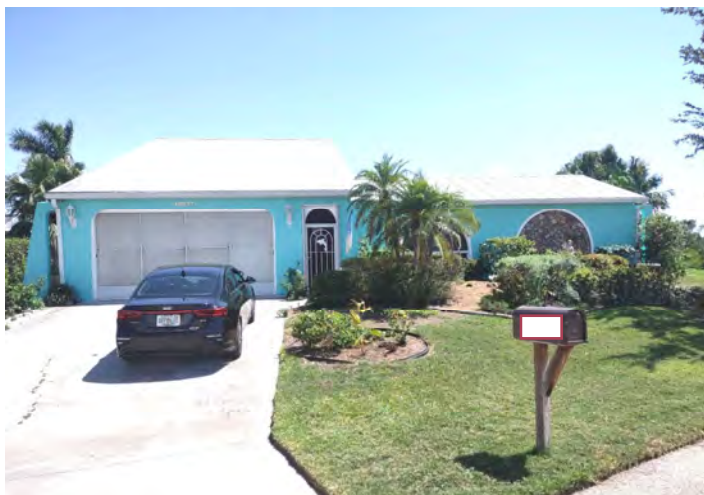
SHOWING NORTH FRONT ELEVATION OF THE HOUSE.

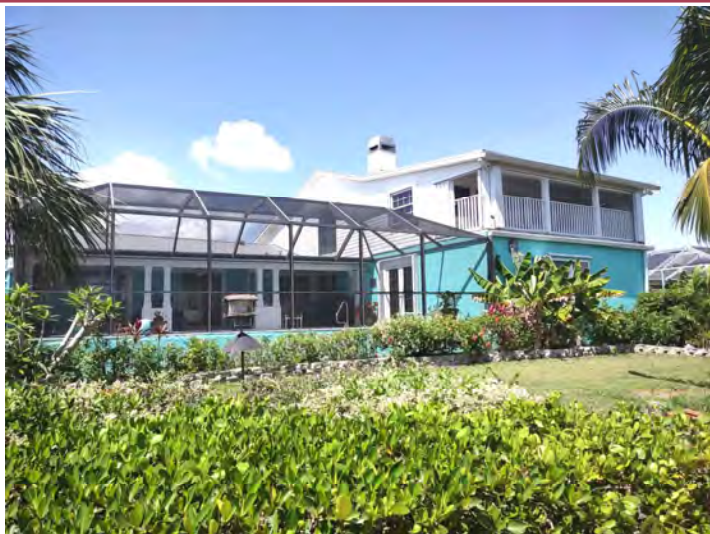
SHOWING SOUTH BACK ELEVATION OF THE HOUSE.

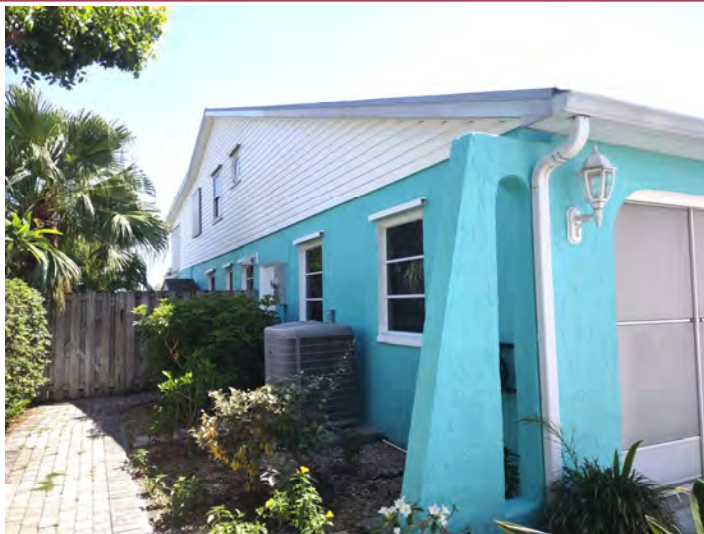
SHOWING EAST SIDE ELEVATION OF THE HOUSE.

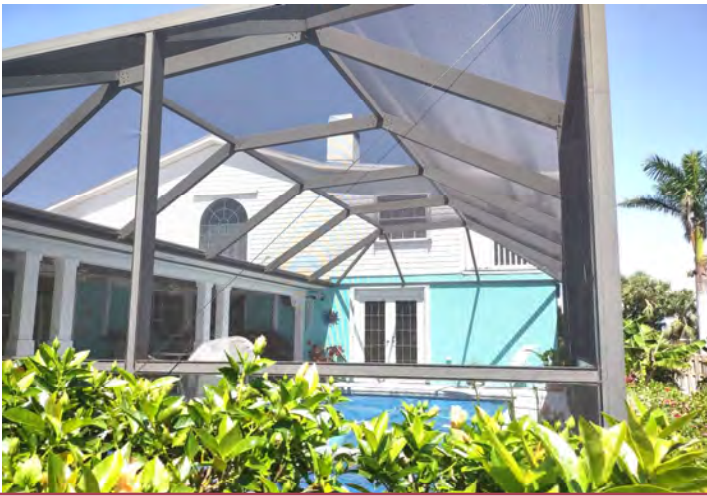
SHOWING WEST BACK SIDE ELEVATION OF THE HOUSE.

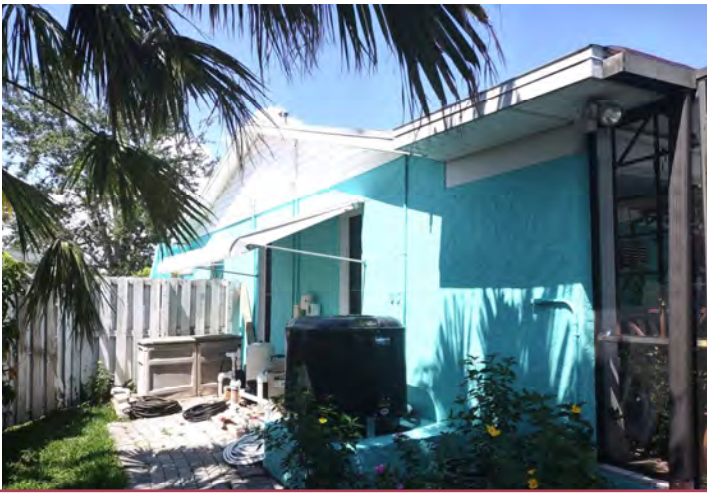
SHOWING WEST FRONT SIDE ELEVATION OF THE HOUSE.

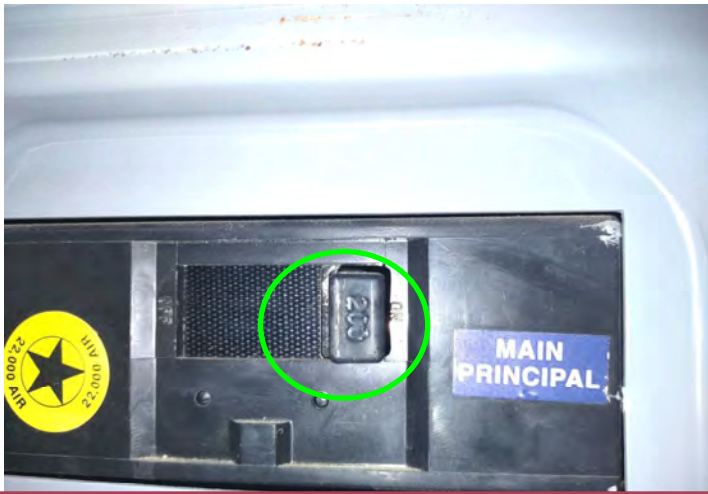
SHOWING 200 AMP MAIN ELECTRICAL PANEL SERVICE SIZE.

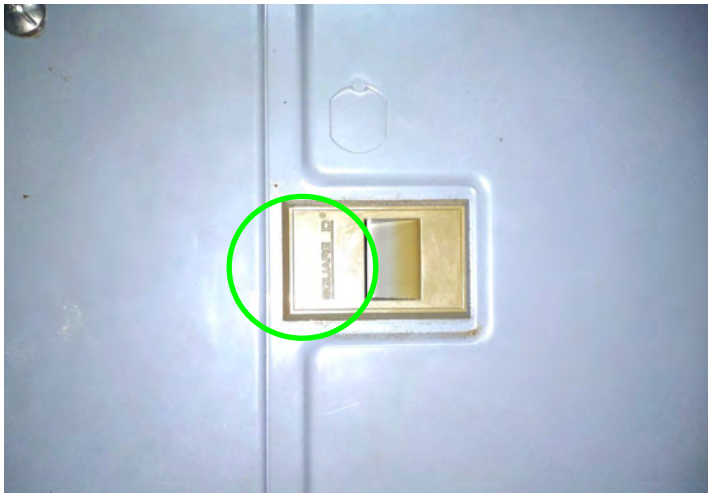
SHOWING 200 AMP MAIN ELECTRICAL PANEL BRAND IS A SQUARE D.

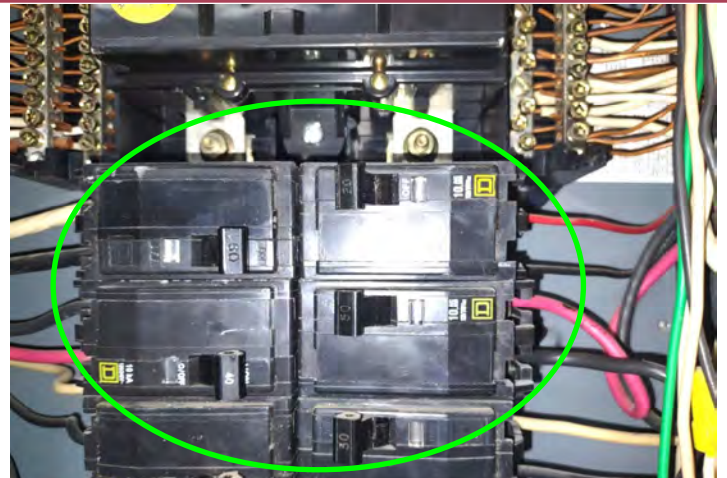
SHOWING 200 AMP MAIN ELECTRICAL PANEL CLOSEUP OF THE CIRCUIT BREAKERS. BRAND IS SQUARE D.

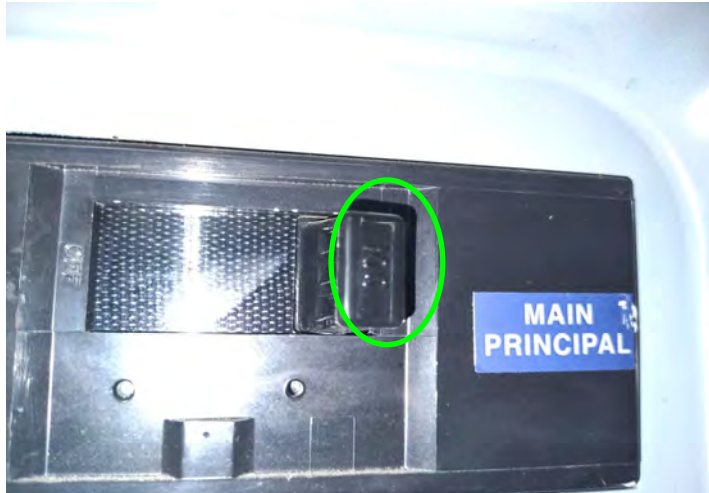
SHOWING 100 AMP MAIN ELECTRICAL PANEL SERVICE SIZE IS 100 AMPS.

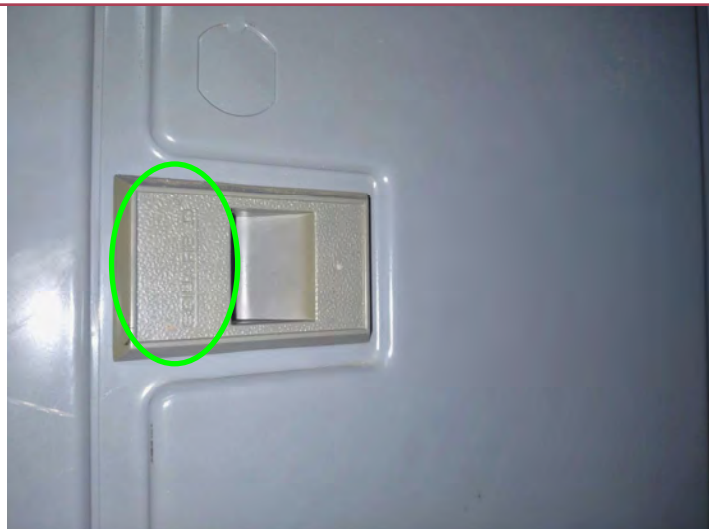
SHOWING 100 AMP MAIN ELECTRICAL PANEL BRAND IS SQUARE D.

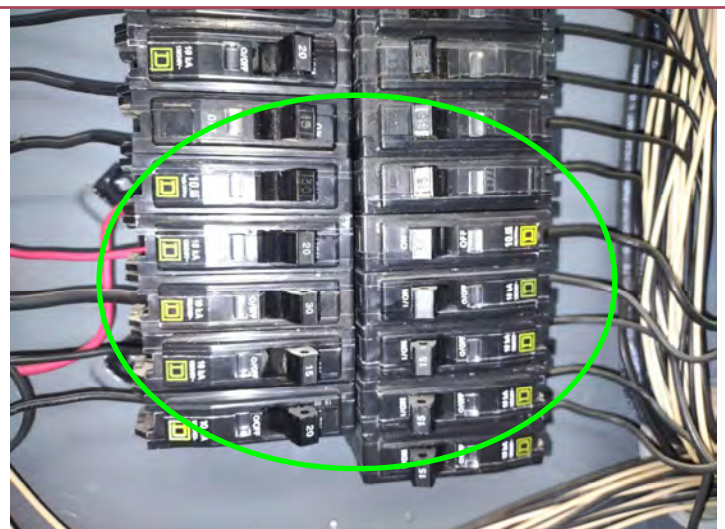
SHOWING 100 AMP MAIN ELECTRICAL PANEL WITH CLOSEUP OF THE CIRCUIT BREAKERS. SHOWING CIRCUIT BREAKERS BRAND SQUARE D.

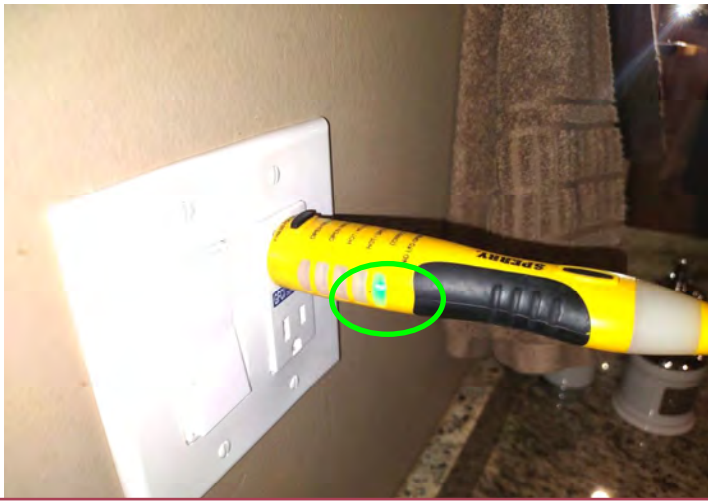
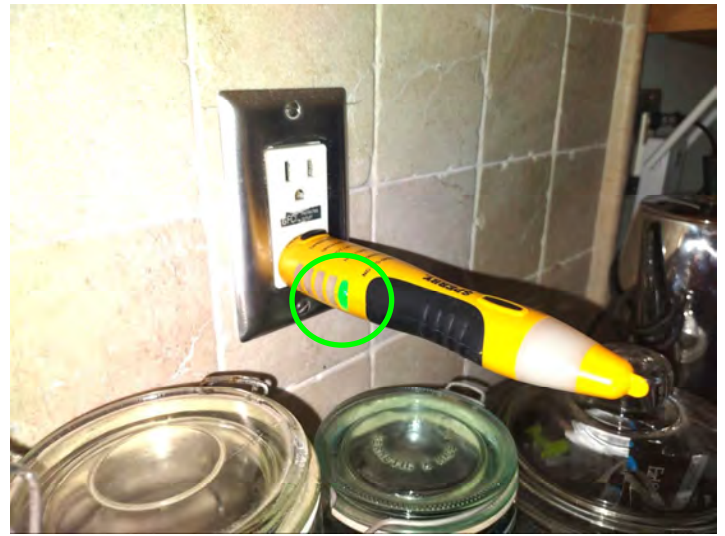
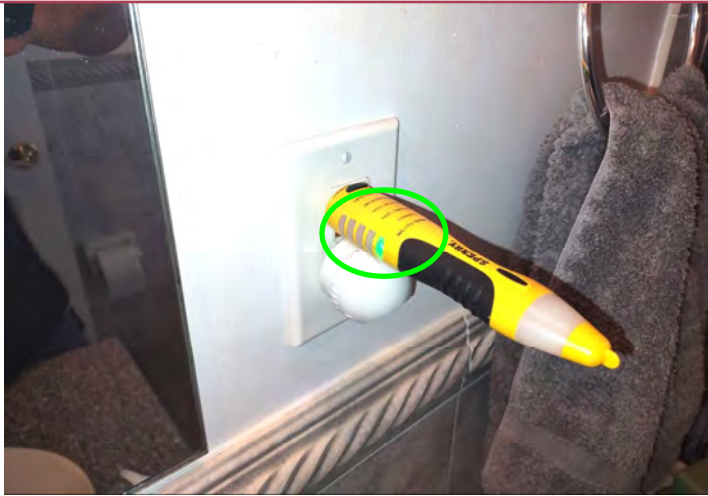
SHOWING RECEPTACLES TESTED IN ABOVE AND BELOW PICTURES WERE ALL WORKING CORRECTLY.

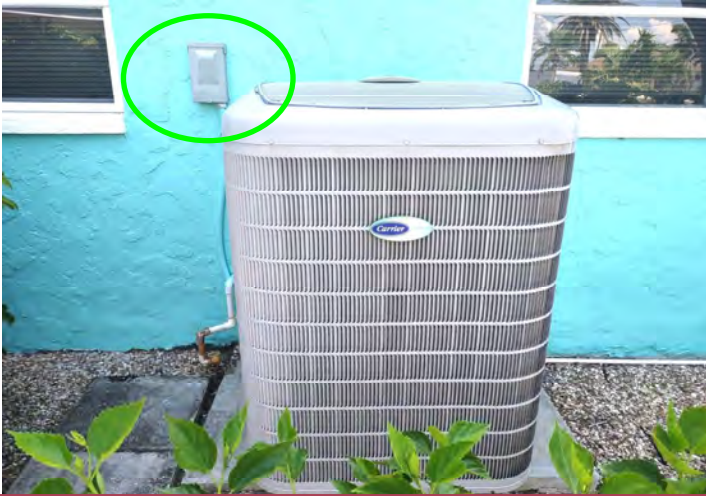
SHOWING AC COMPRESSOR WITH A PROPERLY LOCATED DISCONNECT.

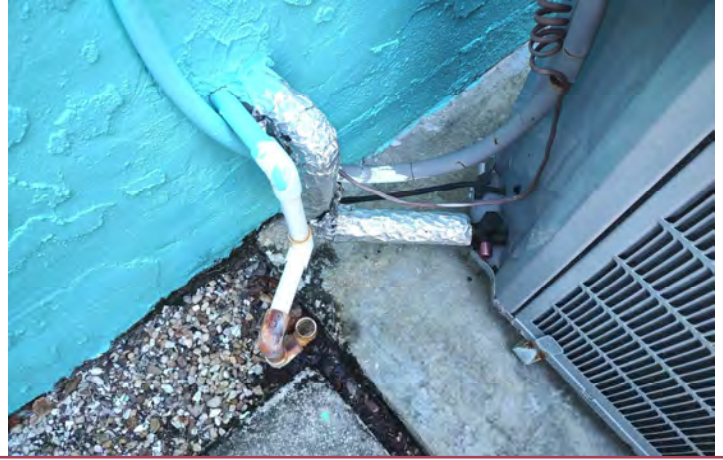
SHOWING AC LIQUID AND SUCTION LINES AND CONDENSATE LINE WITH ADEQUATE DRAINAGE.

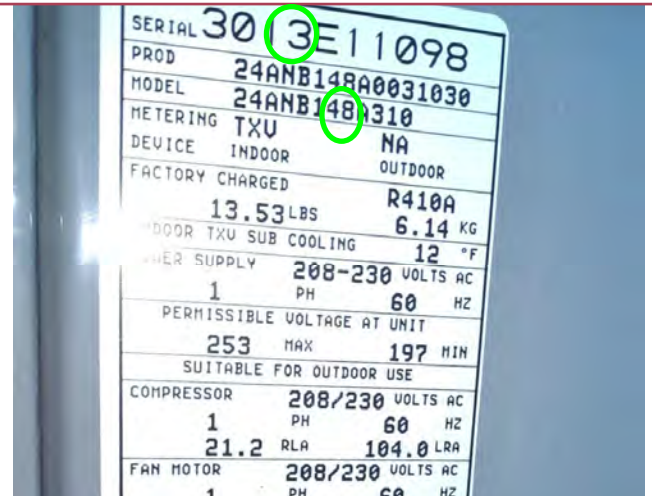
SHOWING AC COMPRESSOR DATA PLATE. MFR DATE 2013 AND A 4 TON UNIT.

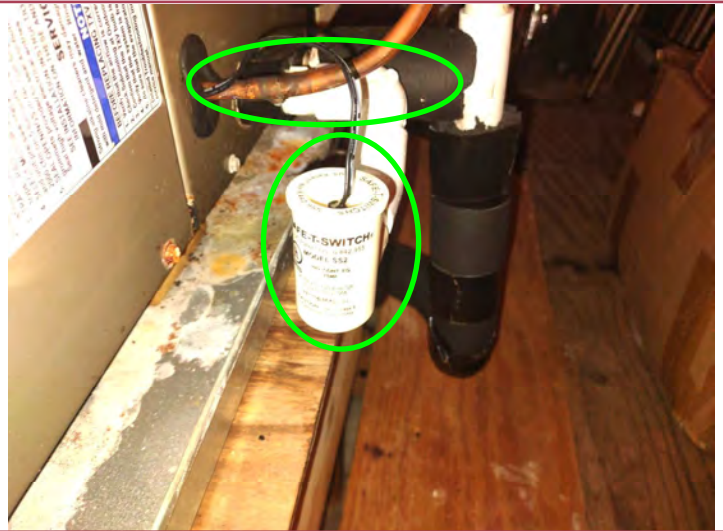
SHOWING AC AIR HANDLER LIQUID AND SUCTION LINES AND AIR HANDLER OVERFLOW SHUT OFF SWITCH. NO LEAKS AT THE TIME OF THE INSPECTION.

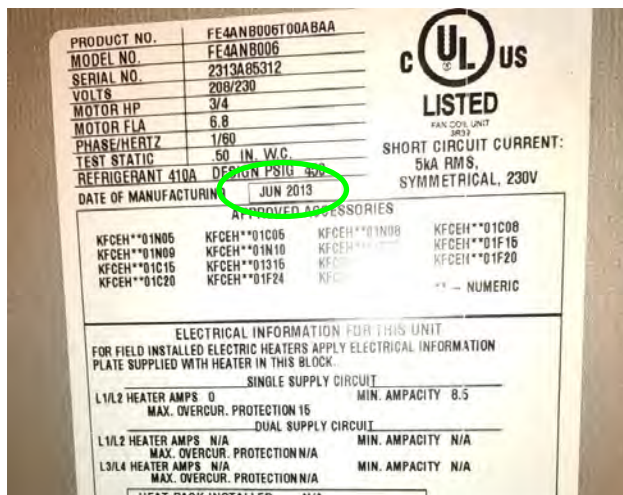
SHOWING AIR HANDLER DATA PLATE. MFR DATE IS 2013.

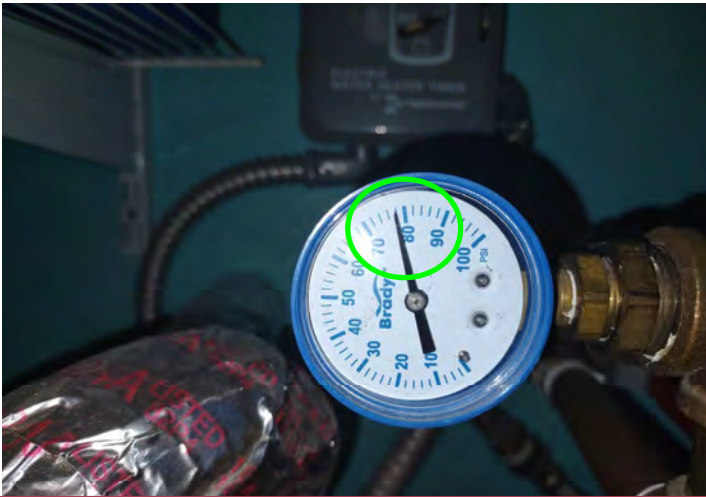
SHOWING ADEQUATE WATER PRESSURE 78 PSI. 30-80 IS ACCEPTABLE.

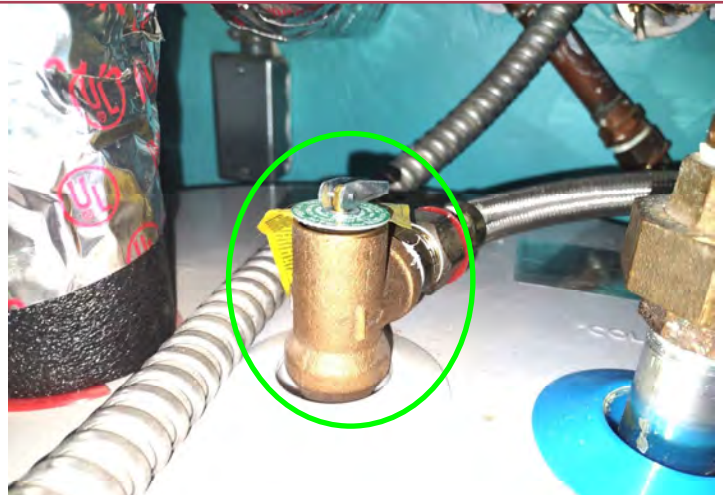
SHOWING WATER HEATER TPR VALVE IS PRESENT.

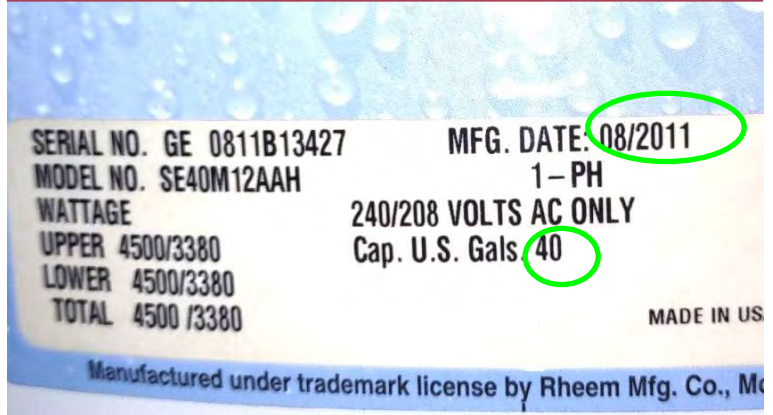
SHOWING WATER HEATER DATA PLATE. MFR DATE IS 2011 WITH A 40 GALLON CAPACITY.

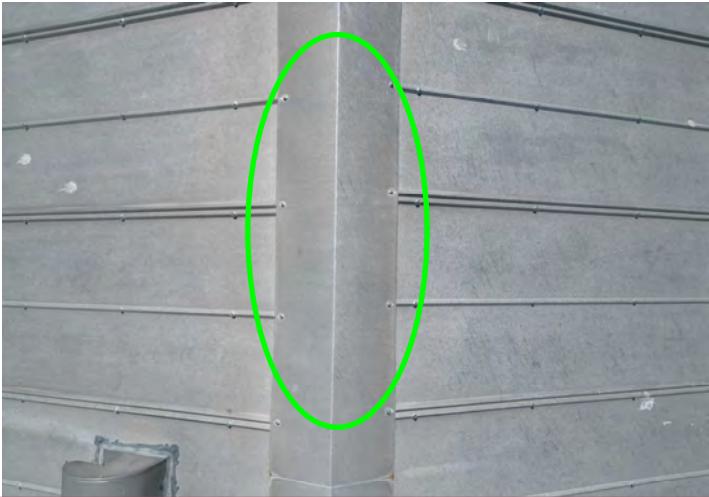
SHOWING CLOSEUP OF THE ROOF RIDGE CAP AND FASTENERS.

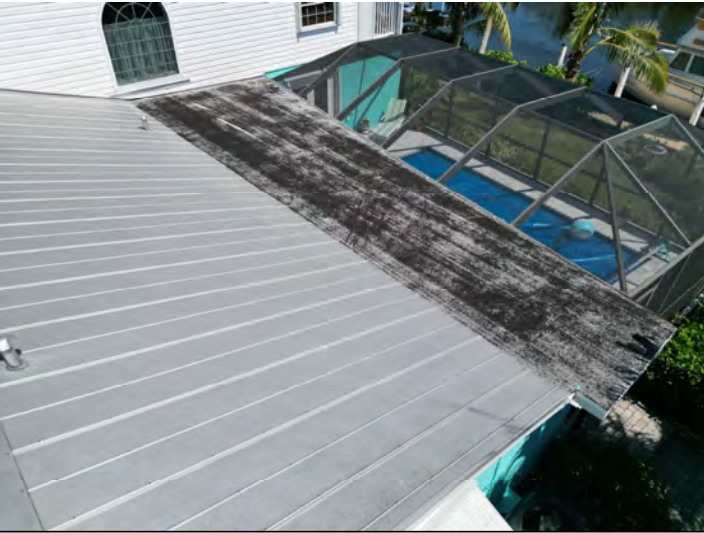
Roofing was acceptable at the time of the inspection with no active leaks.
