**ENGLAND'S HOME INSPECTION
SERVICES LLC.**

4 POINT INSPECTION

123 ANYWHERE TOWN, FL 33333

INSPECTION DATE: 04/25/2023

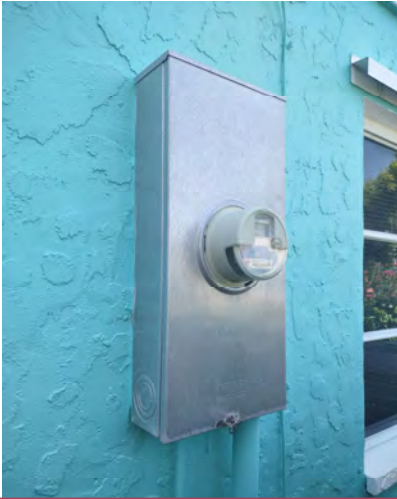
SHOWING MAIN ELECTRICAL SERVICE METER.

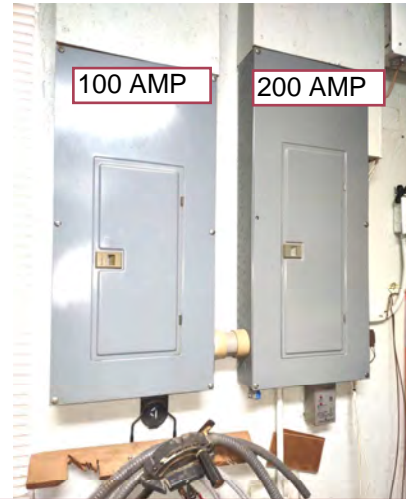
SHOWING BOTH MAIN PANELS WITH COVERS CLOSED. LOCATION IS IN THE GARAGE.

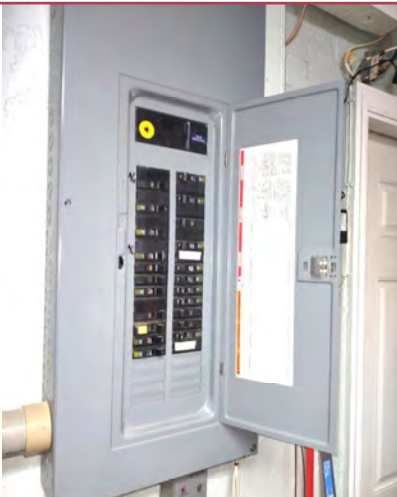
SHOWING 200 AMP MAIN PANEL WITH COVER OPEN AND LABELING PRESENT.

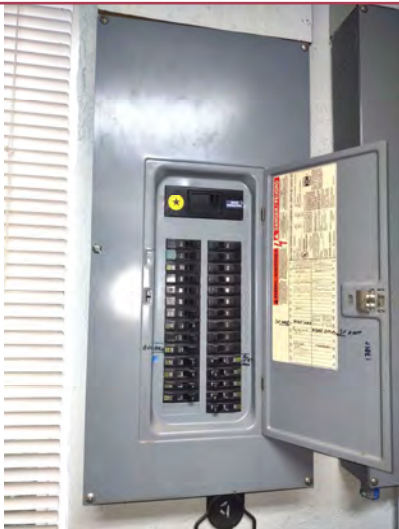
SHOWING 100 AMP MAIN ELECTRICAL PANEL WITH COVER OPEN AND LABELING PRESENT.

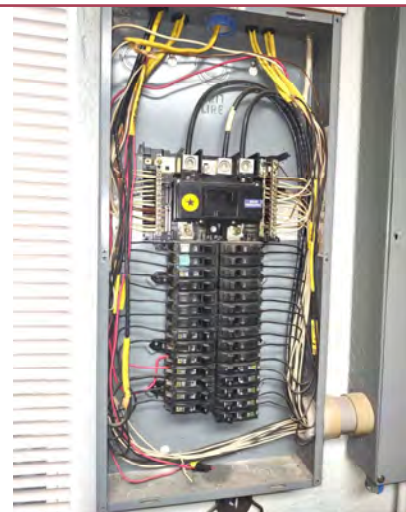
SHOWING 100 AMP MAIN ELECTRICAL PANEL WITH COVER OFF.

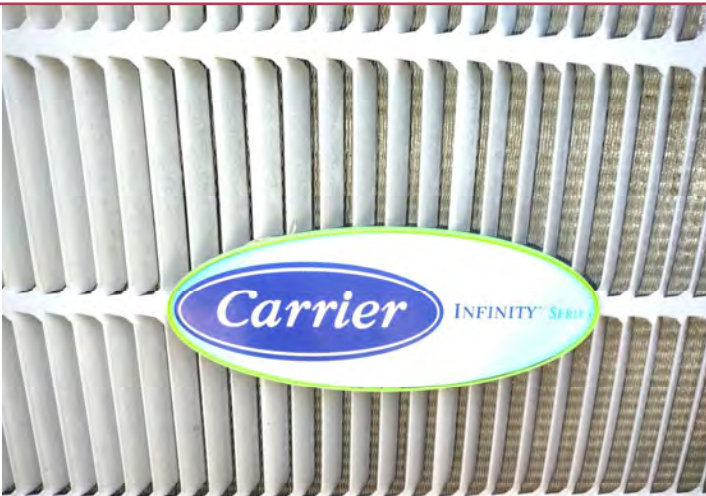
SHOWING AC COMPRESSOR BRAND IS A CARRIER.

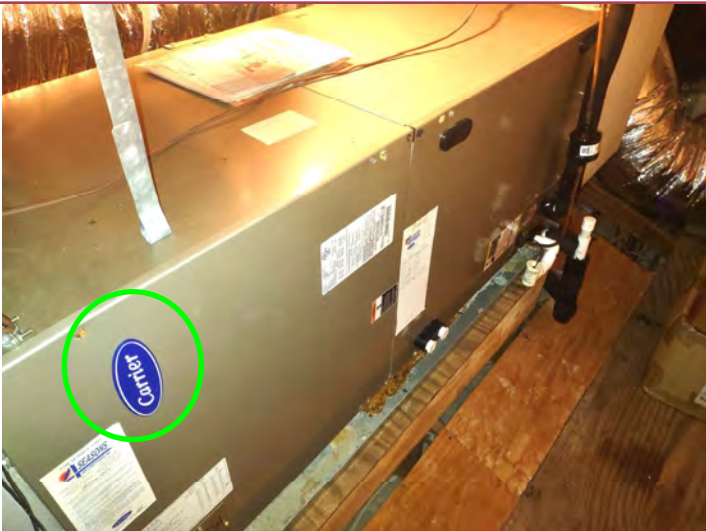
SHOWING CARRIER AC AIR HANDLER UNIT LOCATION IN THE ATTIC.

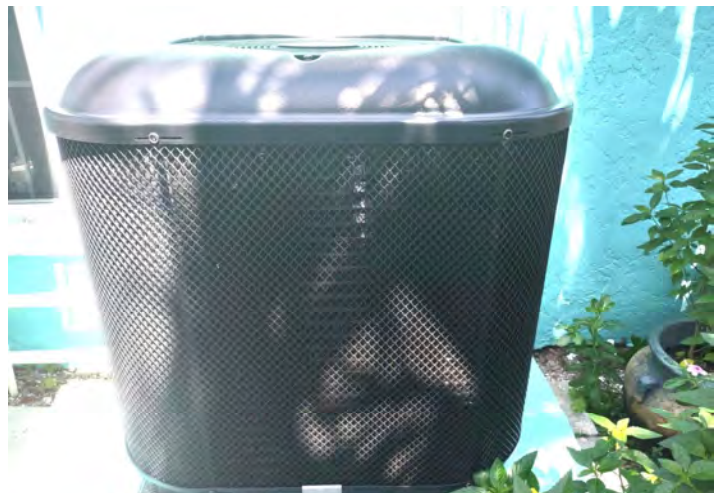
SHOWING SWIMMING POOL HEATER.

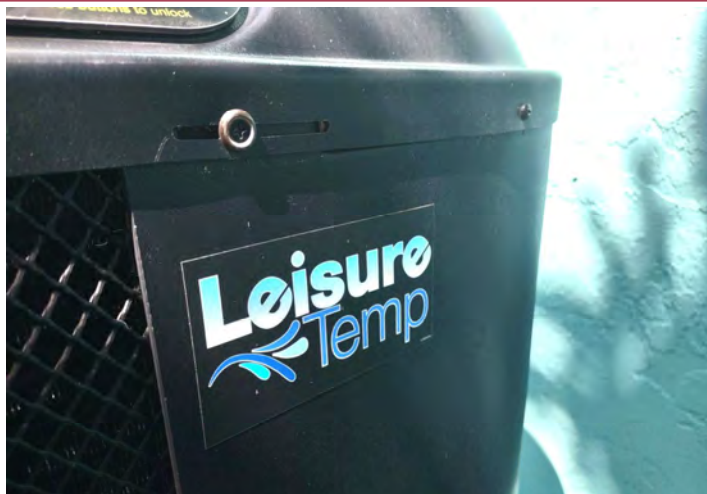
SHOWING LEISURE TEMP HEATER BRAND.

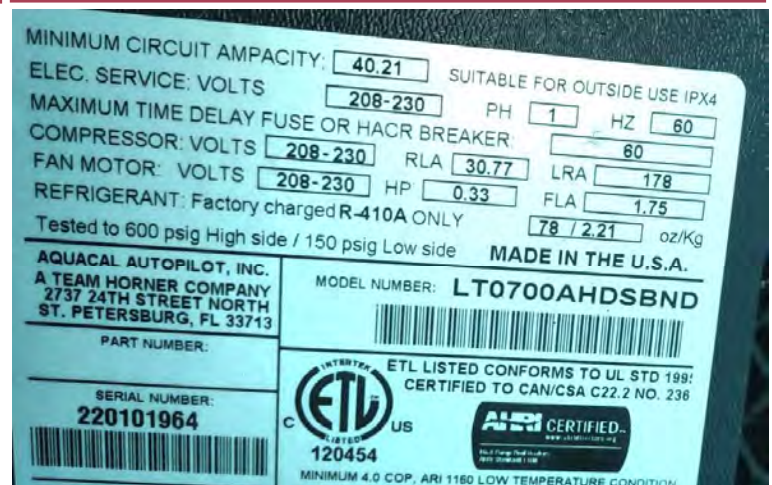
SHOWING LEISURE TEMP DATA PLATE.

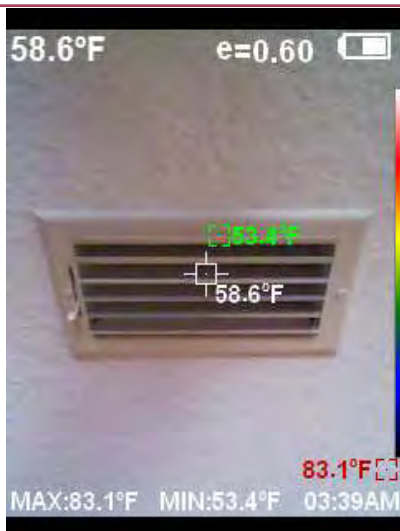
SHOWING SUPPLY VENT INFRARED TEMPERATURE SCAN.

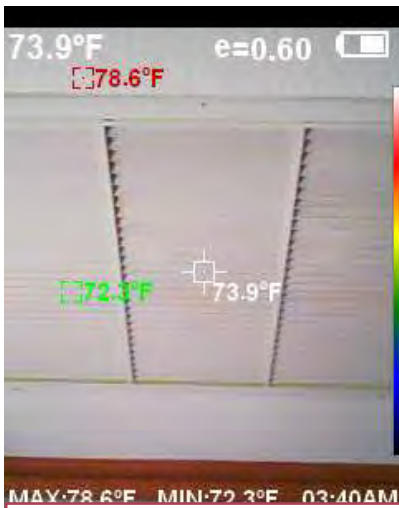
SHOWING RETURN VENT INFRARED TEMPERATURE SCAN

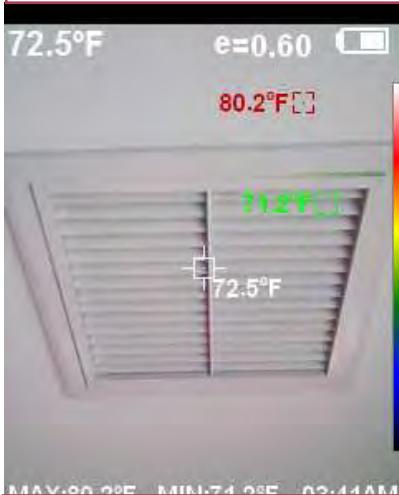
SHOWING RETURN VENT 2 INFRARED TEMPERATURE SCAN.

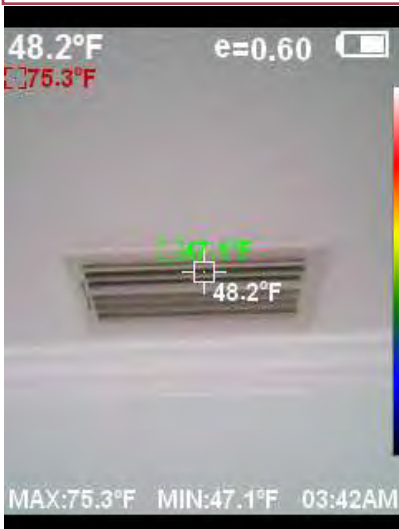
SHOWING SUPPLY VENT 2 INFRARED TEMPERATURE SCAN.

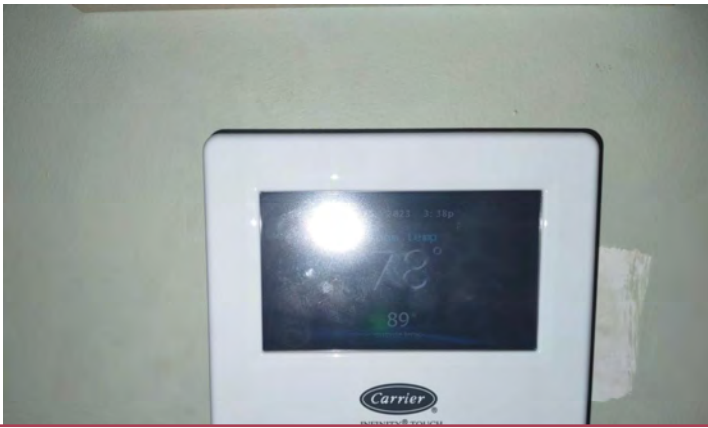
SHOWING THERMOSTAT LOCATION IN THE HALLWAY. SYSTEM WAS OPERATED BY NORMAL THEROMSTAT CONTROLS.

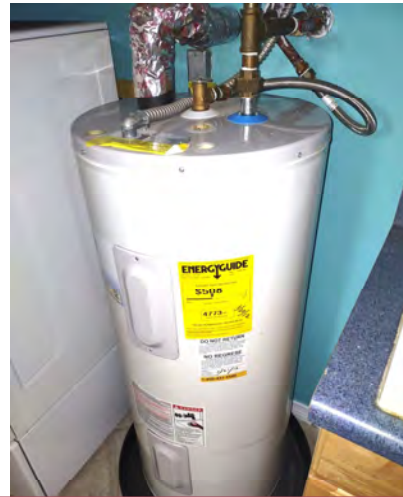
SHOWING HOT WATER HEATER LOCATION IN THE LAUNDRY ROOM.

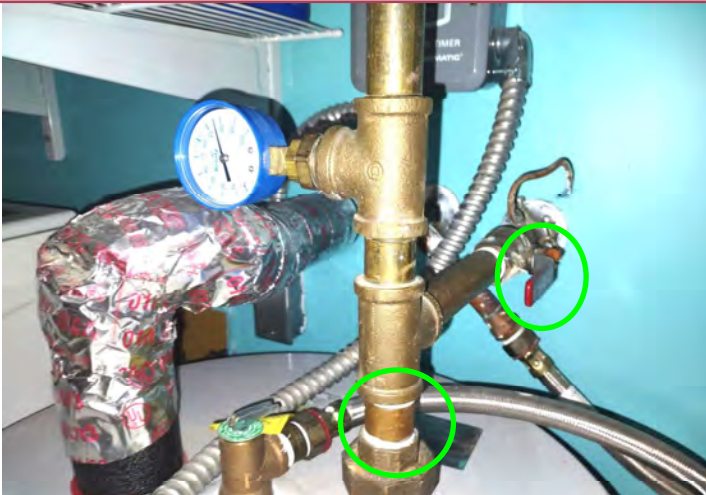
SHOWING WATER HEATER COPPER SUPPLY PIPING AND SHUT OFF VALVE ARE PRESENT.

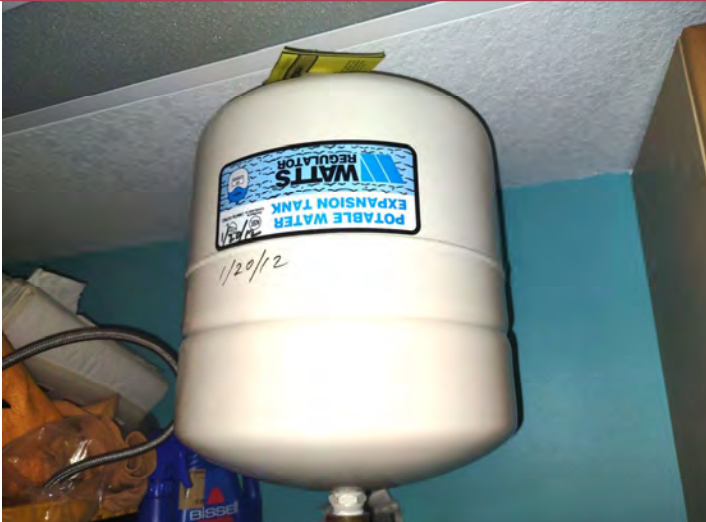
SHOWING WATER HEATER EXPANSION TANK.

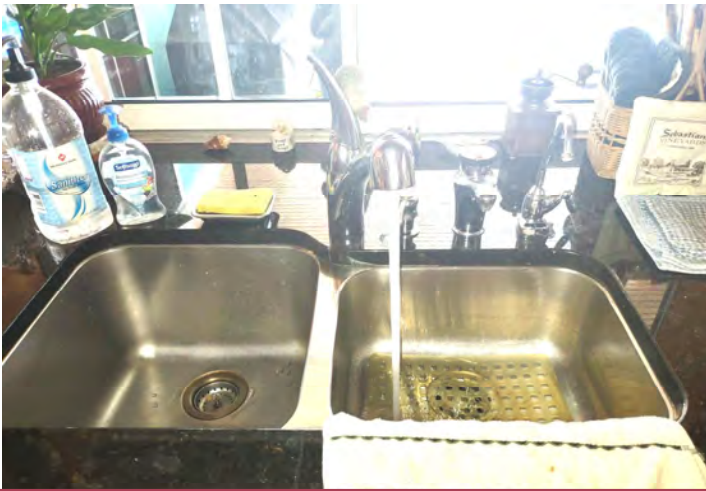
SHOWING KITCHEN SINK WITH ADEQUATE WATER PRESSURE AND DRAINAGE.

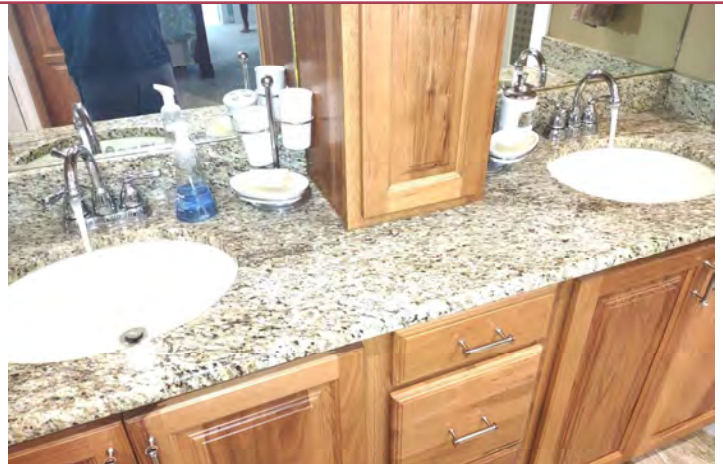
SHOWING BATHROOM 1 DOWNSTAIRS DUAL VANITY WITH ADEQUATE WATER PRESSURE AND DRAINAGE.

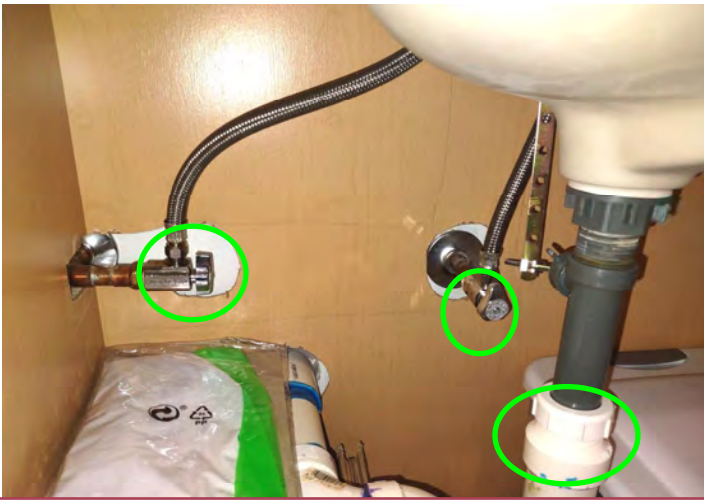
SHOWING DOWNSTAIRS BATHROOM 1 UNDER RIGHT SIDE OF THE SINK QUICK SHUT OFF VALVES PRESENT AND PVC DRAINAGE PIPING.

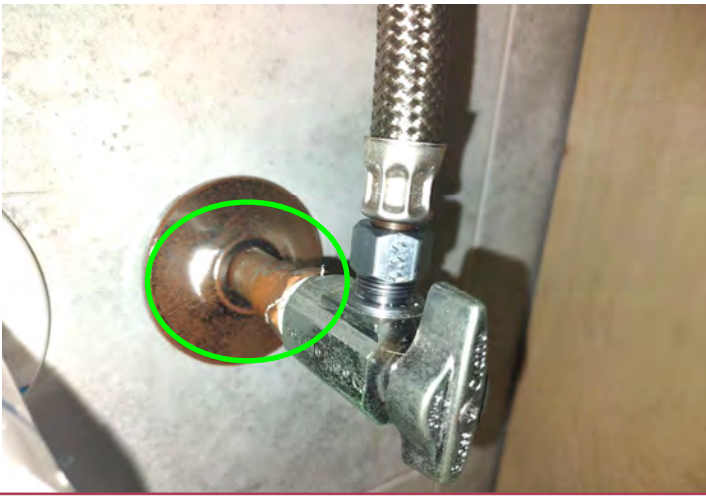
SHOWING DOWNSTAIRS BATHROOM 2 UNDER THE SINK. QUICK SHUT OFF VALVES AND PVC DRAINAGE PIPING PRESENT.

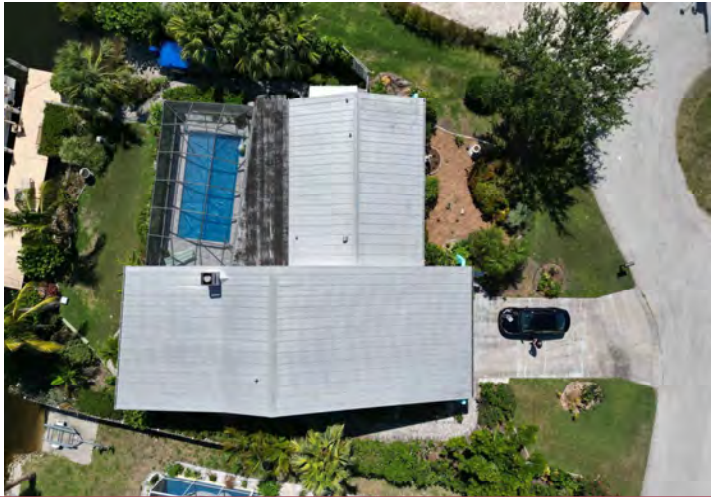
SHOWING HOUSE AND ROOFING OVERVIEW.

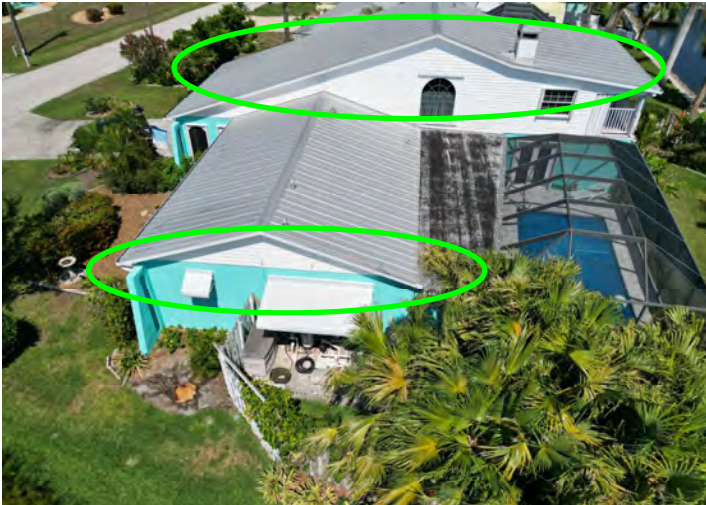
SHOWING WEST GABLE ENDS OF THE HOUSE.

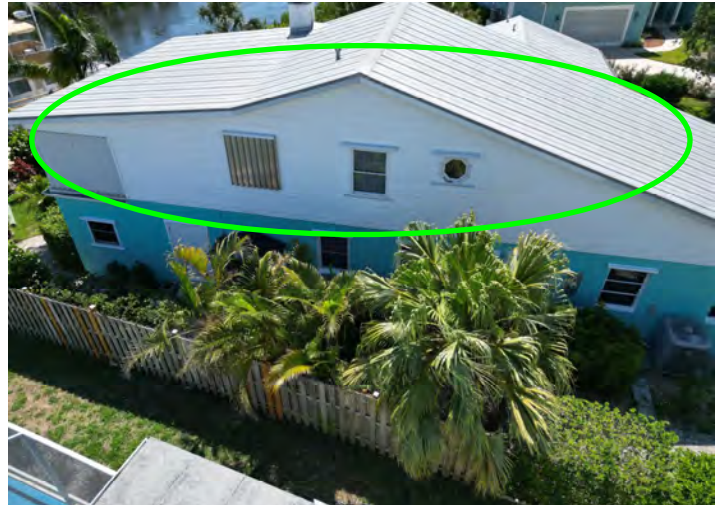
SHOWING EAST GABLE END OF THE HOUSE.
